ROCK PARK CONSERVATION AREA APPRAISAL AND MANAGEMENT PLAN

VOLUME 1 – CONSERVATION AREA APPRAISAL

Prepared for Wirral Council by Donald Insall Associates Ltd, Final Draft May 2009

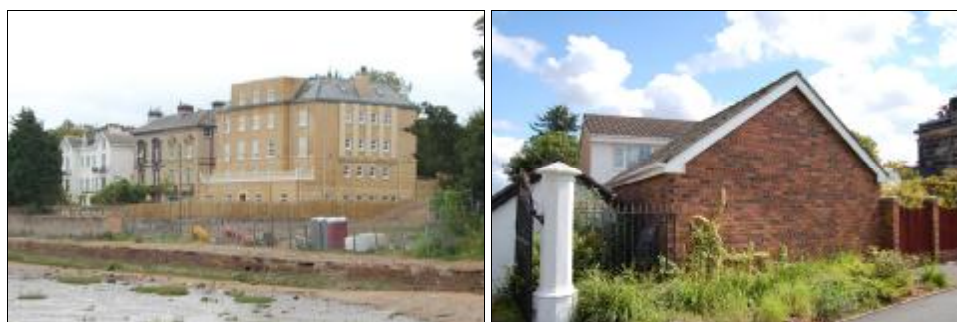
Development in the conservation area which is detrimental to its character or to the setting of its listed buildings: (left) new flats adjacent to 1 Rock Park; (right) Nova House on Rock Park Road

6.2.3 Nova House, on Rock Park Road, however, has a detrimental effect on the setting of both adjacent listed buildings and the character of the conservation area as a whole. Particularly obtrusive are the elements of the site along its road facing boundary: a garage is sited immediately adjacent to the road and is constructed of basic readily available materials to a fairly standard design without reference to the special characteristics of the conservation area. The garage has a direct and adverse effect on the visual relationship between the two neighbouring listed buildings. The fence along the front boundary is also of a basic construction and it detracts from the quality and appearance of the streetscene as a whole. The house itself is of an entirely incongruous scale to the rest of the conservation area and built of inappropriate standardised materials, however, it is slightly set back from the road and the building line, which means that there is the potential for its detrimental visual impact to be lessened by good landscaping in the future.

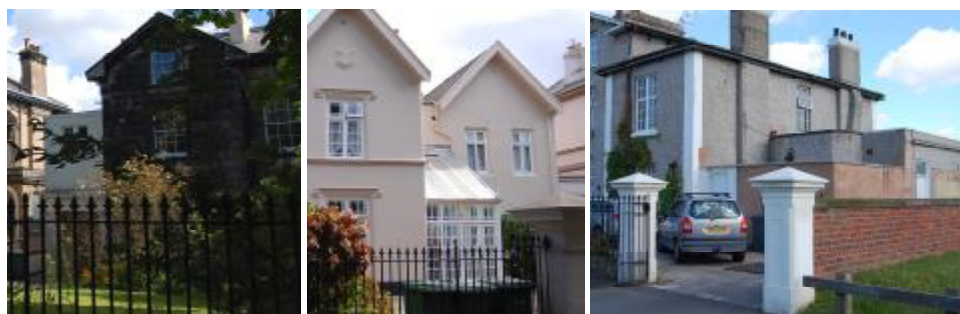
- 6.3.1 There are relatively few extensions within the conservation area of a significant size. Most extensions have been to the rear or sides of houses to provide ancillary accommodation such as porches. In many cases extensions have involved the alteration of existing outriggers and therefore have not substantially changed the form of the building. The most unsympathetic of extensions are likely to be those that confuse the original form of the building and lessen the overall perception of quality. Good extensions would either use the materials and detailing of the original building or be of a modern design and construction that is of a high quality but adequately contrasting to the original.

Extensions within the conservation area. The first two images show extensions of a similar form to elements of the original building, but lacking the quality of detailing, the third shows very poor quality and highly visible single storey additions.

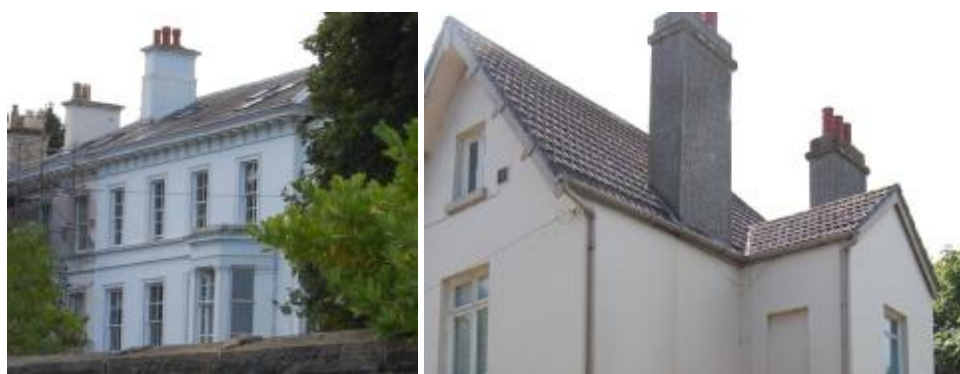
Unsympathetic alterations within the conservation area: (left) rooflights inserted into the roof slopes; (right) concrete pantiles

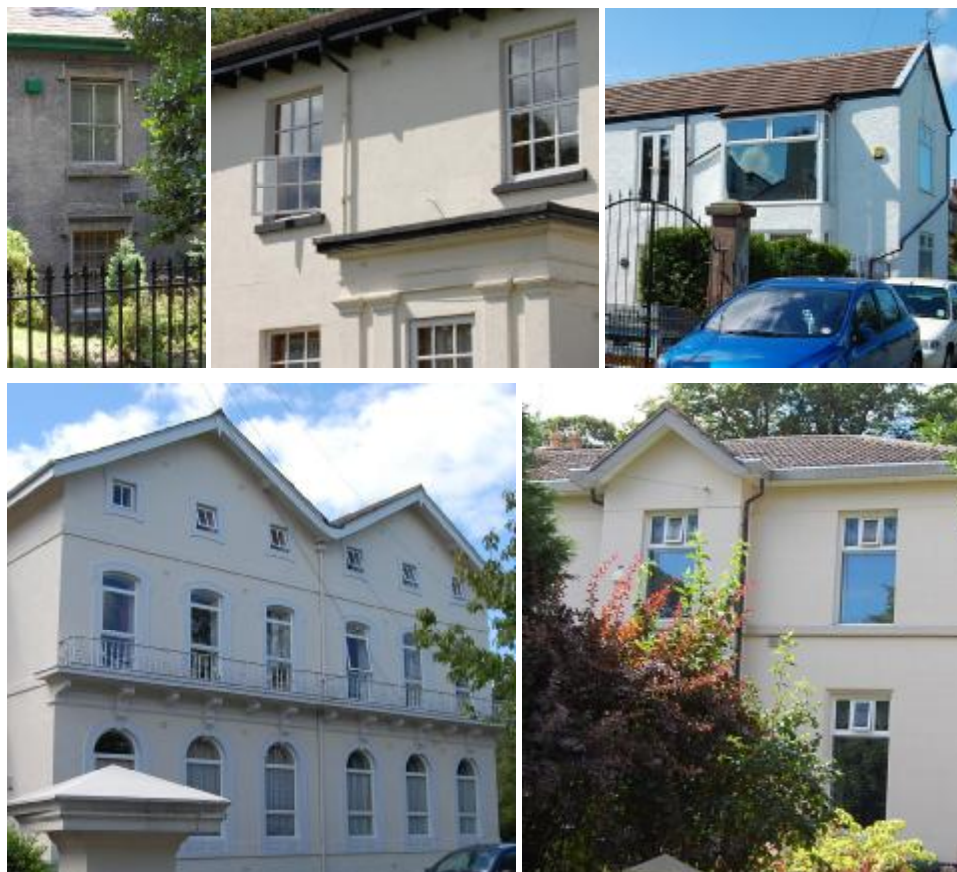
6.4.2 The foremost alteration to historic fabric within the conservation area is the replacement of original doors and windows. These alterations are often well intentioned – to improve the thermal or acoustic performance or to reduce maintenance requirements for instance, but the visual effect, particularly on the architecturally simple buildings is immense. The original sash windows would have had very slim profiles, giving an elegant appearance. In contrast, a UPVC or aluminium replacement, particularly when holding a thick double glazed unit, has considerably thicker framing elements, which are more obtrusive visually and will let much less light into the building. To exacerbate this problem, it appears as though many of the buildings' sash windows were replaced with casements (albeit of a relatively sensitive design) many decades ago, confusing the original design intention of the building.

6.4.3 The reconfiguration of opening panes (particularly when replacing sashes with top-hung casements) dramatically changes the architectural character of the building. Where windows are replaced in timber, these can also adversely affect the appearance of the building where the original detailing is not followed and

often the quality of the timber is far substandard to the original, giving it a short lifespan. There are a few instances where secondary glazing has been used in the village (e.g. in the village hall), which will always produce a more satisfactory visual result than a double glazed equivalent. The use of UPVC windows is more prevalent amongst, although not restricted to, the unlisted buildings.

Replacement windows within the conservation area: (top left) an example of an instance of two different configurations of sash window within a building. It is not clear which is original and either may be appropriate but together they are detrimental to the rhythm of the façade. The bottom windows is an example of a stained finish which is inappropriate to the character of the building; (top centre) the detrimental impact of casement windows feigning to be sashes; (top right) large picture windows which result in an historic building appearing to be modern; (bottom left) illustrating the way that modern windows can adversely affect the overall perception of quality to a façade; (bottom right) modern casements again changing the character of the building.

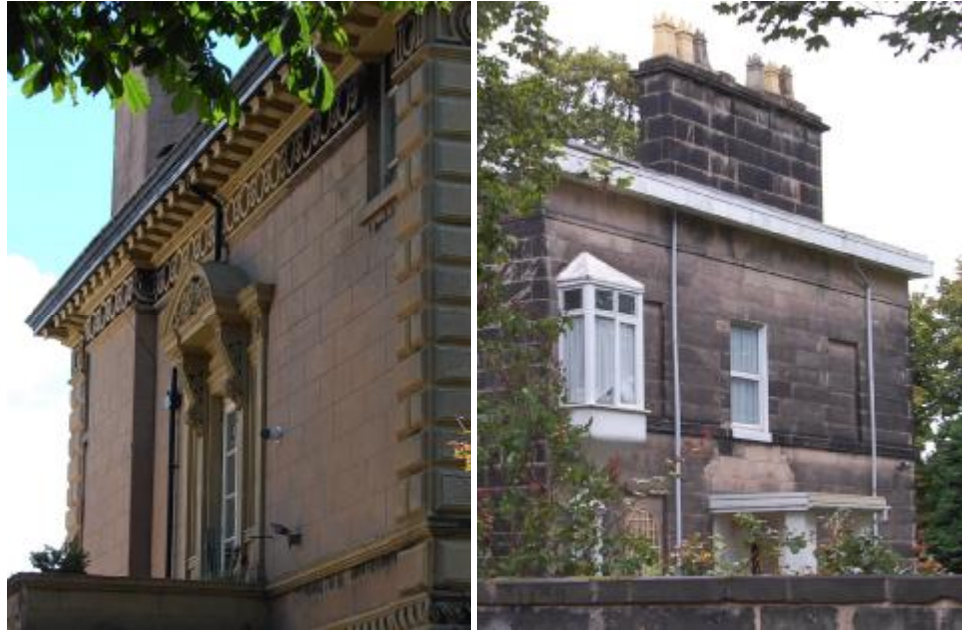
6.4.4 There are a number of instances where new openings have been inserted into the walls of historic buildings. The carefully elevations of the buildings are generally particularly well proportion and as a result any new opening upsets the balance rhythm and geometry of the existing fenestration or may change the character of an intentionally plain façade. The effect of inserting a new opening through existing fabric where it penetrates through details such as cornices is particularly great.

Photographs illustrating the detrimental impact of inserting new openings. The left-hand example shows a small window penetrating through the decorative cornice, the right shows an oriel window (possibly older) and a modern canopy that have unbalanced and changed the architectural quality of the façade. Both of these facades are particularly prominent.

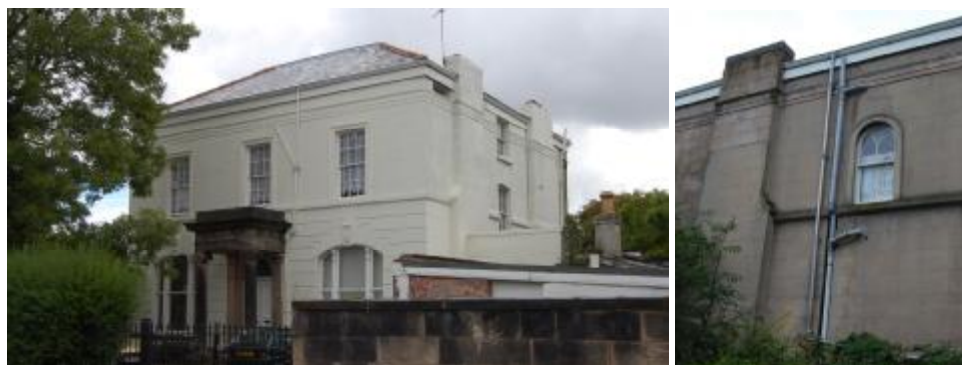
6.4.5 There are a number of further issues, which do not involve the loss or damage to historic fabric but have a detrimental affect on the appearance of the conservation area. All of these matters could be changed without or with little cost, therefore can be considered management issues. These include:

Management issues: (left) a recently painted façade; (right) waste and soil vent pipes, together with a modern fascia treatment.

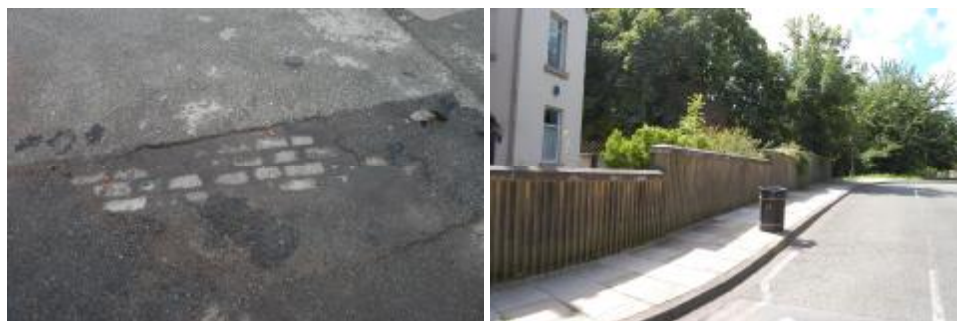
6.5.1 Many of the roads (most notably Rock Park itself) do not have pavements, however, where pavements exist, they are of modern materials, such as concrete slabs, with the exception of some stone kerbs. Roads are all tarmaced, although there are some areas of granite setts showing through around the junction of Bedford Road East and Rock Lane East. Although these surfaces are generally fit for purpose, they are not of a quality that corresponds to that of the listed buildings.

(left) granite setts beneath tarmac; (right) modern concrete slab pavements with concrete walling, presumably constructed at the time of the by-pass

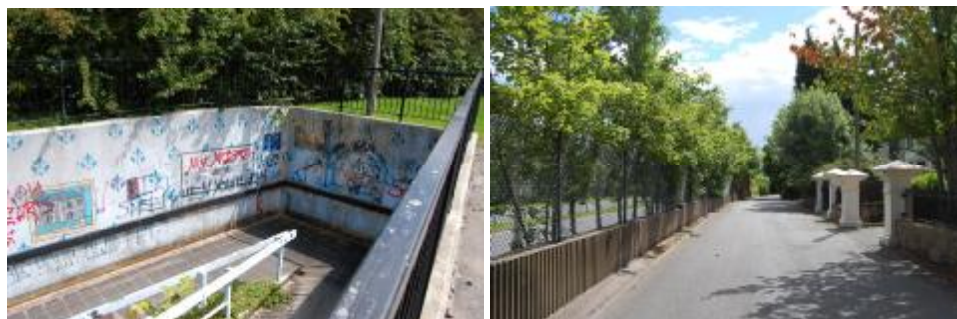
6.5.2 Many of the most obtrusive public realm works are associated with the bypass. The underpass, connecting the two halves of Rock Park, despite decoration by the residents at the same time as the Conservation Area Partnership Scheme, has been covered in graffiti making it intimidating and an undesirable means of access, even during the day. As a result of resident pressure it has now been closed as a right of way. There are also long lengths of concrete walling which does not reflect the high quality natural materials seen in the original Rock Park elements. Immediately alongside the bypass the walling has additional chain-link fencing behind it or in other areas basic aluminium fencing is used. All of these elements are entirely unacceptable within an area of historic interest and add to the detrimental impact of the modern road itself.

(left) the underpass; (right) wall and fencing alongside the by-pass

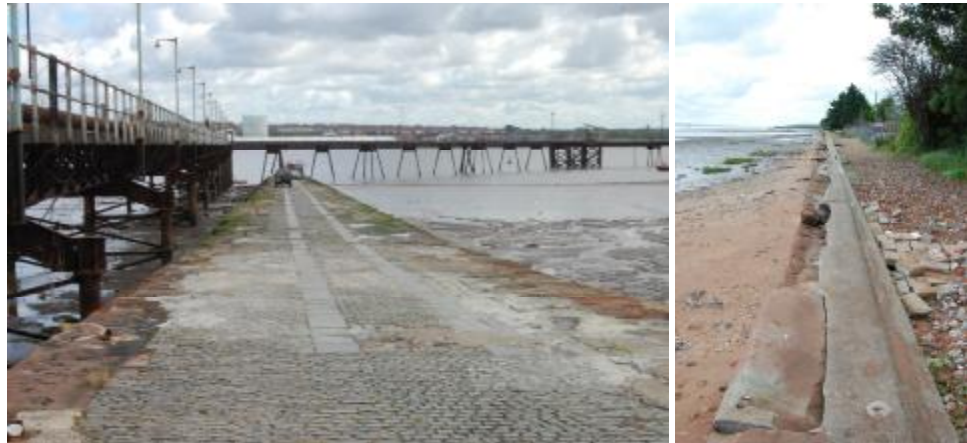
6.5.3 The jetty, pier and esplanade are all historic features of great tourist potential but in an unsafe condition. Despite their appearance, considerable amounts of

historic fabric remain, but are being lost due to erosion, vandalism and poor maintenance.

The jetty, pier and Esplanade
