Removal of Sand from Hoylake Beach adjacent to North Parade

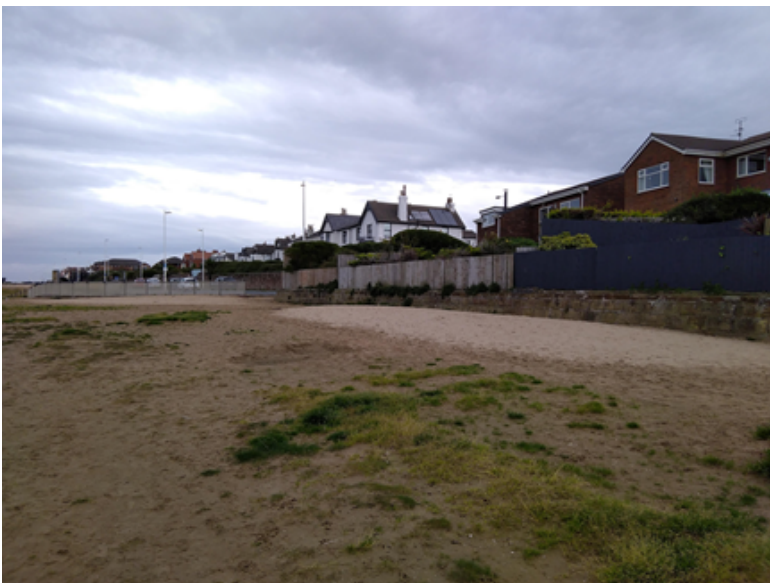
1) Photograph from the beach of King's Gap Slipway showing sand accumulations

Wind-blown sand will be removed from these locations and relocated 150m from the sea wall toward the tide line (as per map fig 1). The sand will be spread out and flattened.

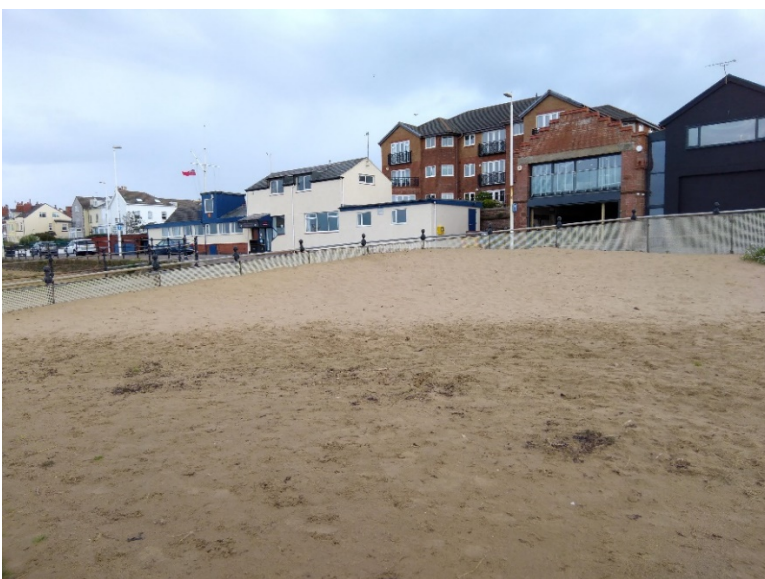
2) Photograph from the beach of Alderley Road slipway and Hoylake Sailing Club showing sand accumulations

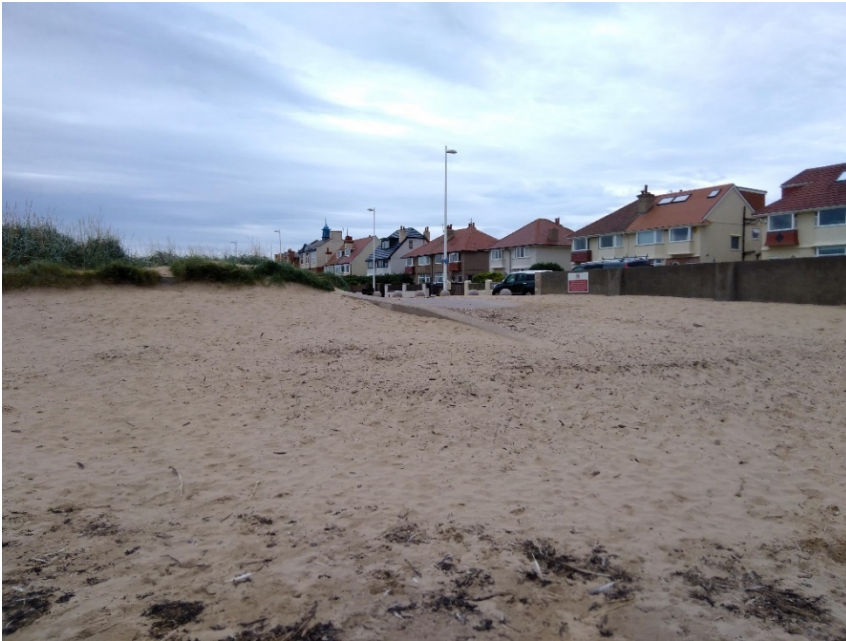
3) Photograph from the beach of sand accumulation at the new Lifeboat Station west slipway
