FLOOD EVENT INVESTIGATION WEST KIRBY 09 APRIL 2024

Lead Local Flood Authority investigation into the flood event of 09 April
2024 at West Kirby, Wirral

Document title: Flood Event Investigation
Subtitle: West Kirby 09 April 2024
Reference: S19/10/20240409
Status: Final/2

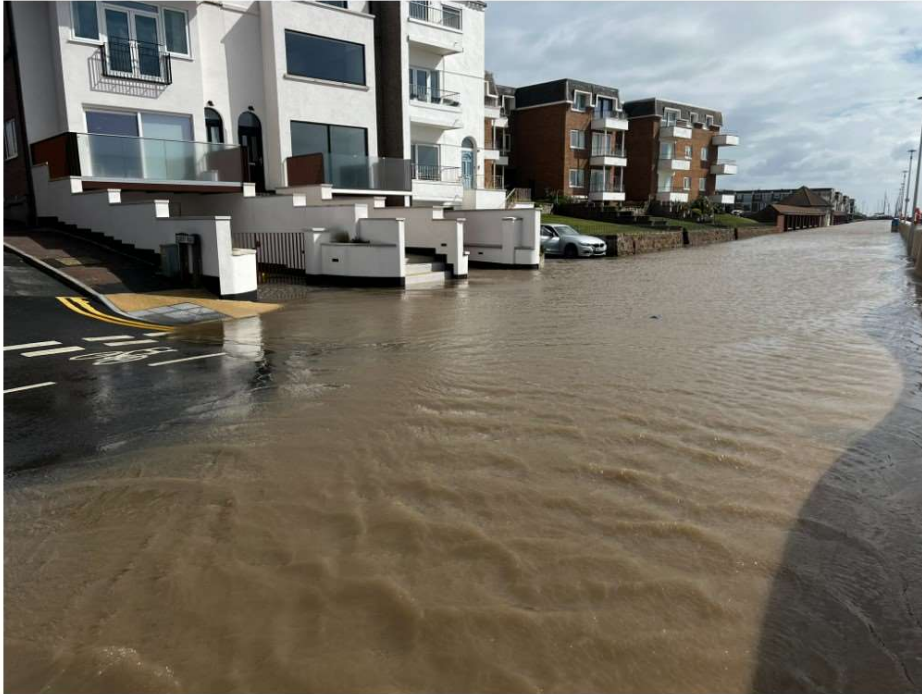
9 April 2024 at 14:07
Wirral - West Kirby - 11,399 of 12,516

Figure 5 Water retained on the highway 2 hours after high water

The Highway Authority also has responsibility for operation and maintenance of the highway drainage system which serves South Parade. The highway drainage system dates from the construction of South parade around 1900 and its function is to drain surface water from the highway surface and does not form part of the flood defence. The water that was blown over the flood wall also contained sand and debris which likely blocked a number of the highway inlets once the system began to draw down and caused a delay in the draining of the highway once outfalls were no longer tide locked. See Figure 5 above.

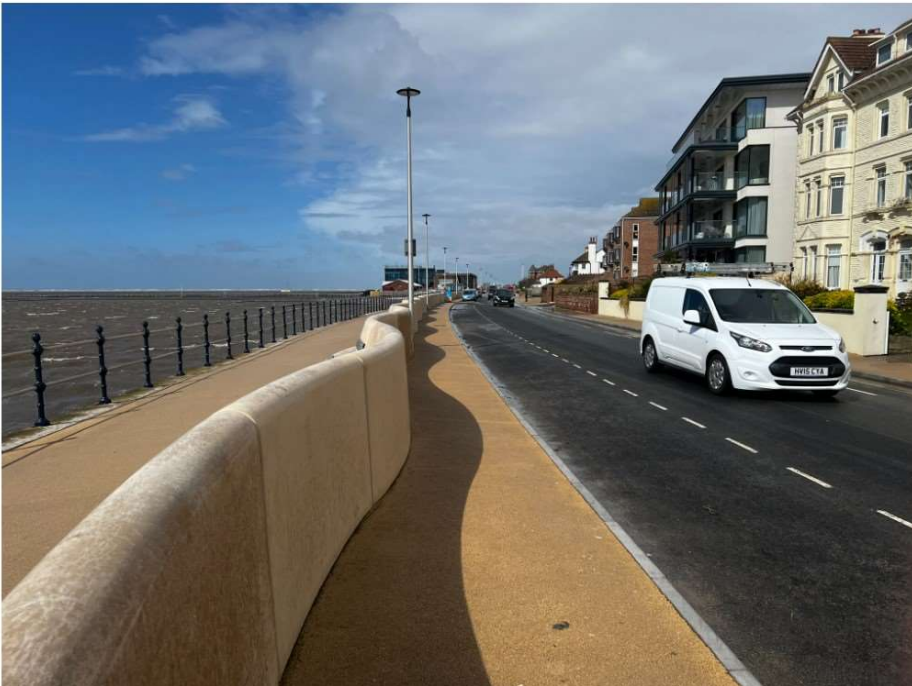
9 April 2024 at 14:11
Wirral - West Kirby - 11,405 of 12,516

of sliding and swing gates also aided the drain down of standing water on the highway. The highway was clear of standing water after 4 hours, although some areas were clear after 2 hours, as evidenced in Figure 6 below.

Figure 6 South Parade clear of water 2 hours after High Water
